Manhole Inspection Summary

Manhole # S23K__059MH

Location Address: **S Calhoun St**

Cross Street: **Ramsay St**

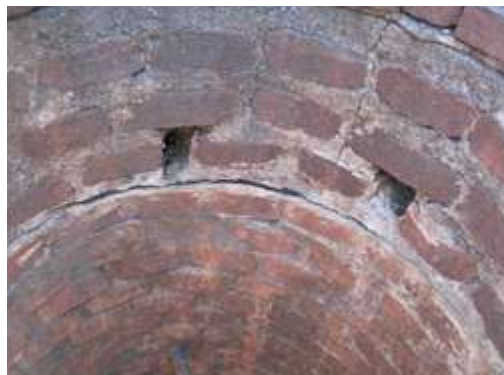
Defect 10

Count: **7** Missing: **1** ☒ **Corroded**

missing mortar & rung

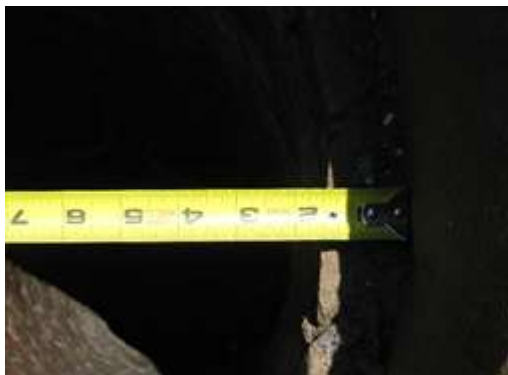
Defect 11

Offset: **1.5** (in.)

1.5 Frame offset

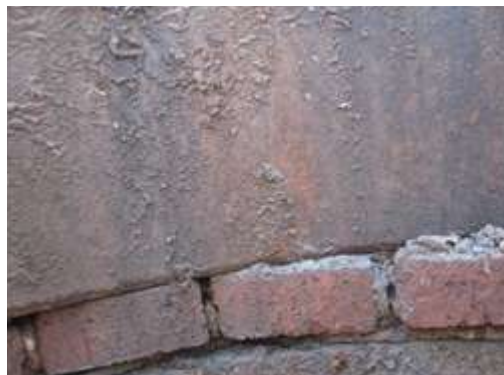
Defect 7

Condition: ☐ Sound ☐ Cracked ☐ Root Intrusion ☒ **Loose Brick** ☐ Deteriorated

Infiltration: ☐ None ☒ **Joint** ☐ Cracks ☒ **Mortar** ☐ Roots ☐ Wall

loose bricks, infiltration @ frame-lid as well as chimney-frame

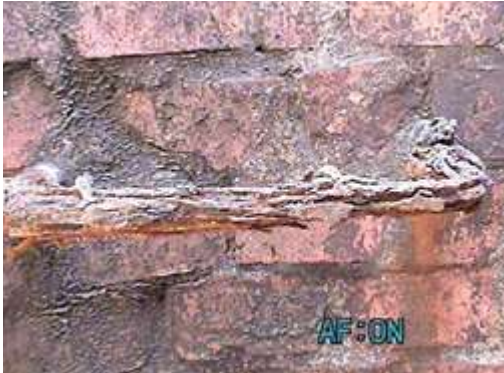
Defect 6

corroded rungs

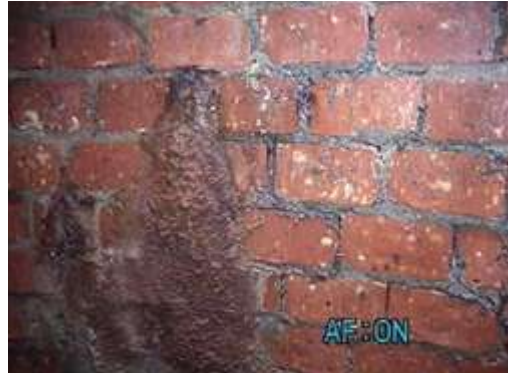
Defect 3

Infiltration: ☐ None ☐ Joint ☐ Cracks ☒ **Mortar** ☐ Roots ☒ **Wall**

infiltration corbel

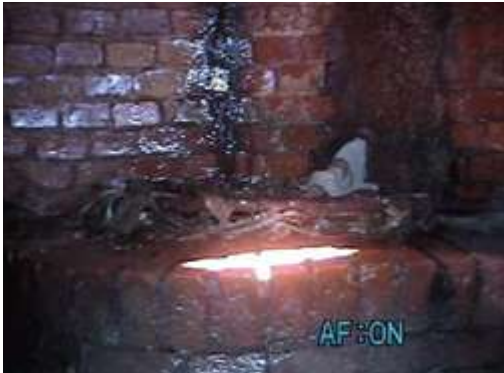
Defect 1

Infiltration: ☐ None ☐ Joint ☐ Cracks ☒ **Mortar** ☐ Roots ☒ **Wall**

infiltration barrel and debris on bench

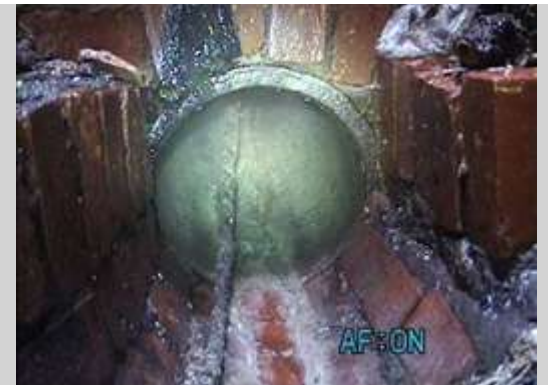
4 O'Clock Inflow

Pipe Height: **8.4** (in.) Rod and Bar (Angled)
Pipe Material: **Clay** ☐ Pipe Lined
Invert Depth: **12.25** (ft.) Flow Characteristics: **Slow**
Deposits: ☐ None ☐ Mud ☐ Sludge ☒ **Debris** ☐ Grease
Silt Depth: **1** (in.) Deposits Extent: **Light**
Infiltration: **None** Pipe Seal Cond: **Sound**

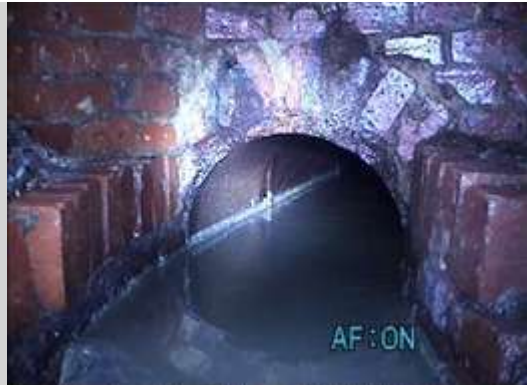
6 O'Clock Inflow

debris in 6:00 portion of channel
